**IDAHO TRANSPORTATION DEPARTMENT**

CATHODIC PROTECTION OF BRIDGE DECKS

ITD-RP071

Research Project 71

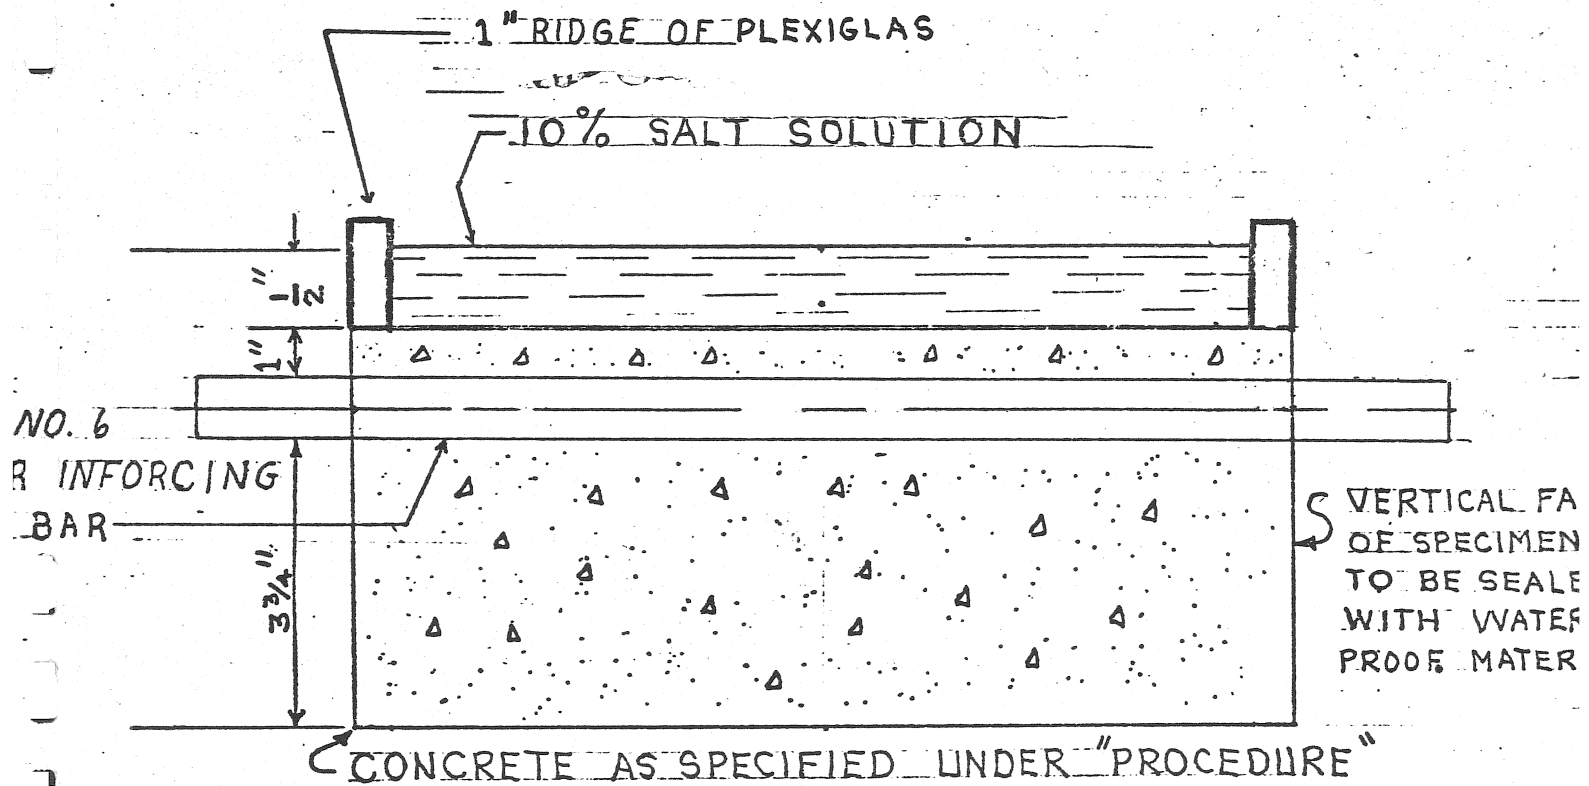
Test Specimen for Investigation of Electrolytic Protection of Reinforcing Steel in Concrete

Eight 6" W x 6" H x 12" L test blocks were made, each with a No. 6 rebar case lengthwise in the middle of the block one inch below the top. The blocks were made and cured in the moist room for two weeks, and then air dried in the laboratory at room temperature for seven weeks. Air drying was used to permit deeper and faster penetration of the 10% salt solution when it was placed on the plant mix surfacing. Anodes were made of perforated sheets of aluminum, magnesium, and steel wire mesh heavily galvanized with zinc. We were unable to obtain sheet zinc at that time. There were two samples of each type -- that is, two with aluminum anodes, two with magnesium anodes, two with zinc plated steel anodes, and two control samples with no anodes. The anodes were simply laid on top of the block, and a one inch thick asphaltic concrete mat laid on top of the anode. A plexiglass enclosure was then placed on top of the asphalt mat to act as a reservoir for a 10% salt solution.

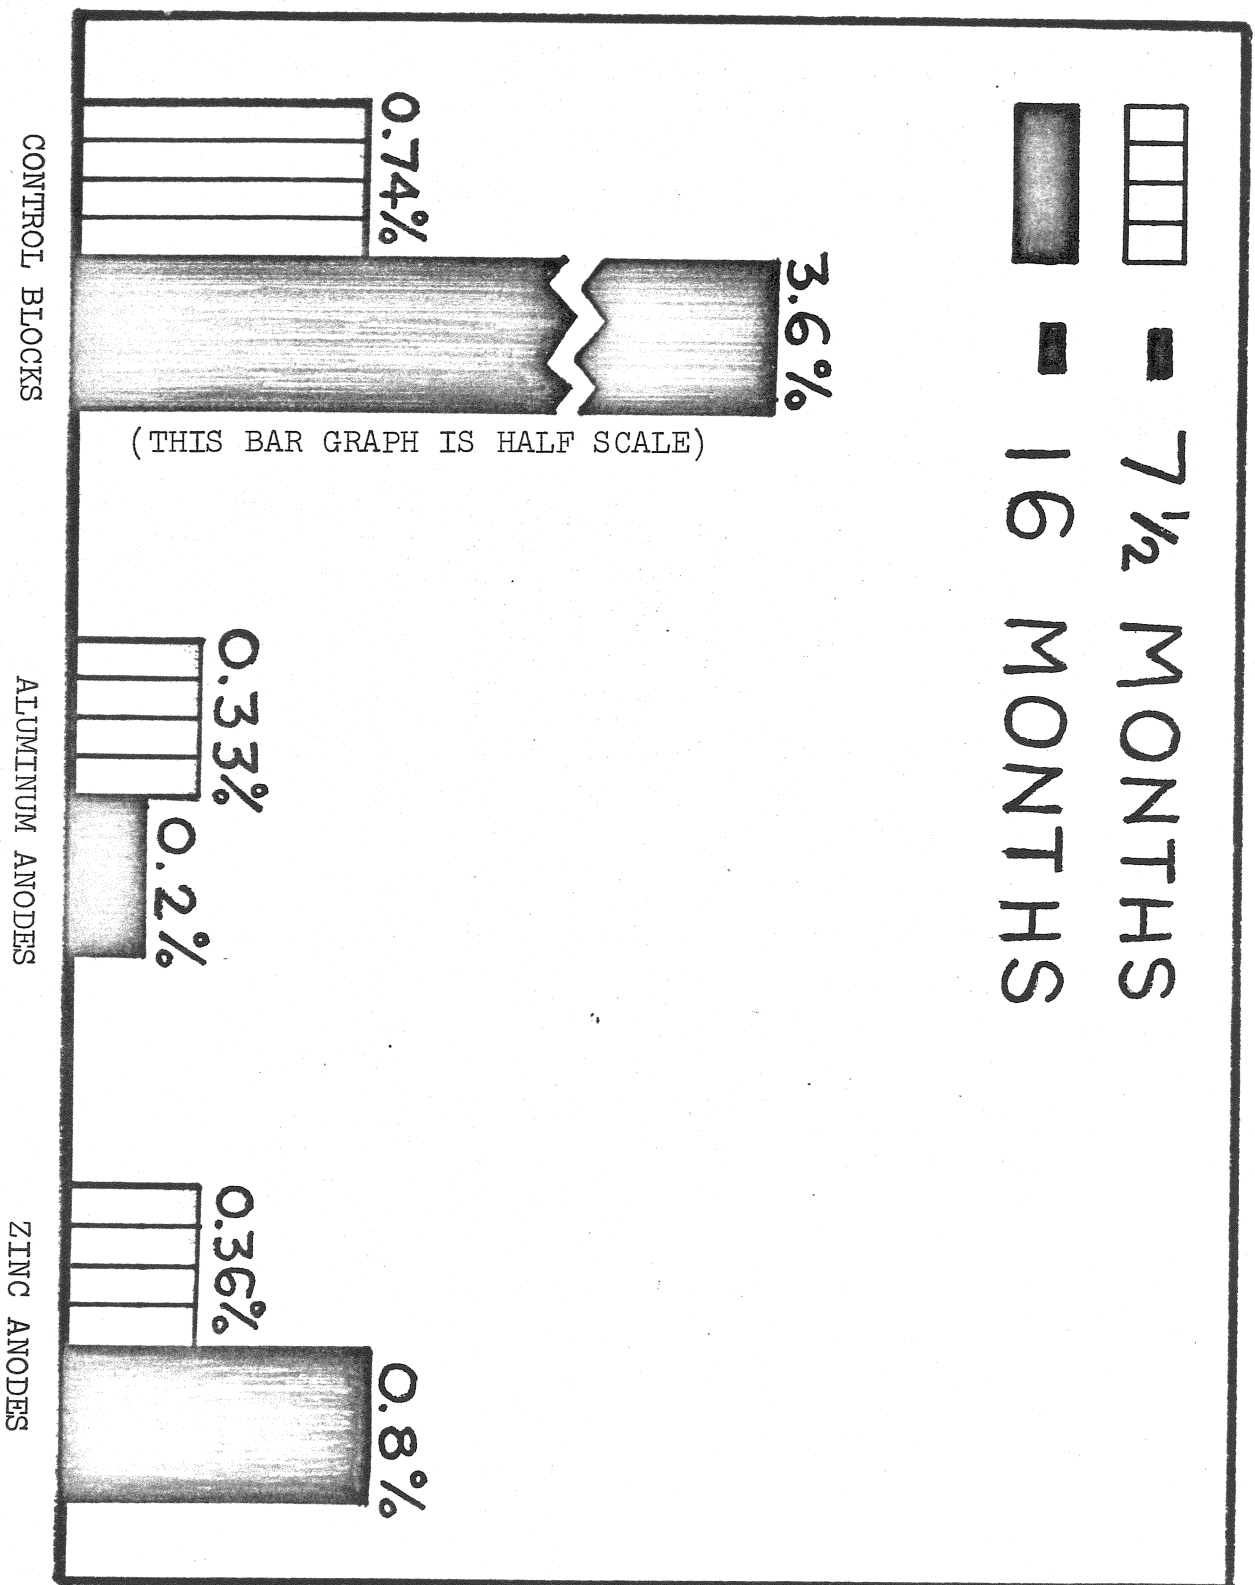
**Figure 2.** Weight Loss From Steel Rebars in Concrete Test Blocks With No Anodes. (Control Blocks), Aluminum Anodes and Zinc Anodes After 7 1/2 Months and After 16 Months.

Half-cell potentials on the zinc anode specimen had increased from -200 millivolts to -430 millivolts in 16 months. Examination of the specimen showed the zinc plated wire anode to be badly corroded with a 70% weight loss, while the steel reinforcing bar was only slightly corroded with a 0.8% weight loss. A faint crack was noted the entire length of the concrete block.

Half-Cell potentials on the aluminum anode specimen increased from -180 millivolts to -530 millivolts in 16 months. Examination of the specimen showed the aluminum anode to be much less corroded with a 3.5% weight loss than the corresponding zinc plated anode with a 70% weight loss. The steel reinforcing bar in the aluminum anode test specimen was very slightly corroded with a 0.2% weight loss. This was only a quarter of the rebar weight loss in the zinc plated specimen. A fine crack extended about half the length of the concrete block.

Half-cell potentials on the control specimen increased from -315 millivolts to -490 millivolts in 16 months. Examination of the steel reinforcing bar showed it had corroded more with a 3.6% weight loss than the corresponding steel reinforcing bar in either the zinc plated anode test specimen or the aluminum anode test specimen. This is shown in Figure 1 which compares the weight loss for all rebars after both 7 1/2 months and 16 months. There was a wide crack the length of the block directly over the rebar and another finer crack about two inches away, both of which showed rust stains. The reinforcing steel was severely rusted and deeply pitted as much as 1/8 inch over the entire surface area exposed to the concrete.

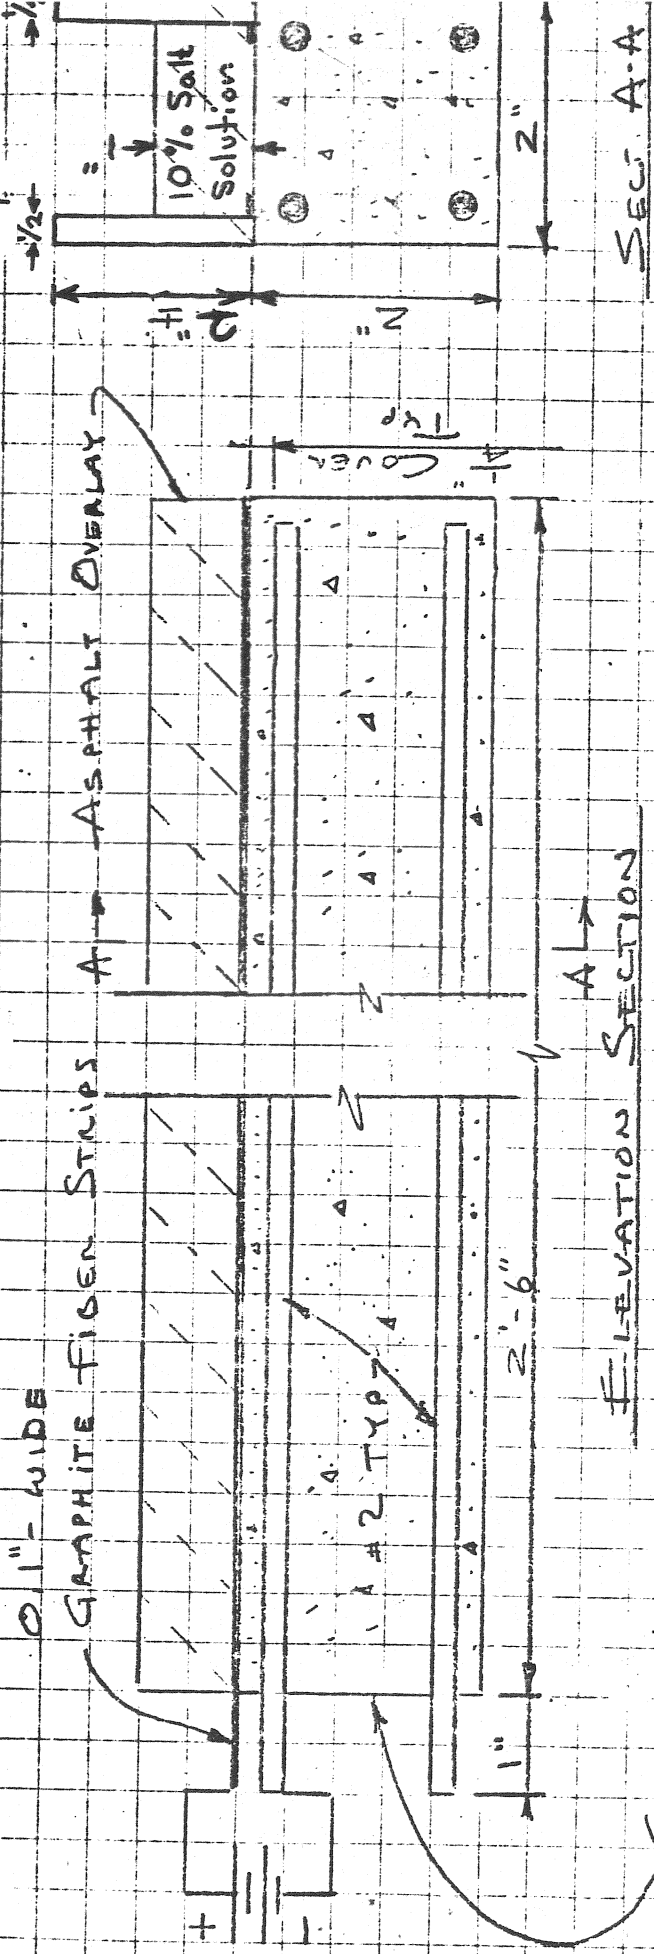
FIGURE NO. 3

CONCRETE WITH  
1/8" MAX AGGREGATE

NOTE - THE 1/4" COVER DIMENSION AND 0.1" WIDTH OF GRAPHITE FIBER DIMENSION ARE THE ONLY DIMENSIONS THAT ARE AT ALL CRITICAL.

# TEST BLOCKS (MAKE 4) FOR GRAPHITE-FIBER TEST

Six 2" W x 2" H x 30" L test blocks were made on January 12, 1976, each with four Number 2 rebars cast lengthwise in the block as shown in Figure 3. The blocks were cured in the moist room for two weeks. They were then removed from the moist room and air dried in the laboratory until March 16, 1976.

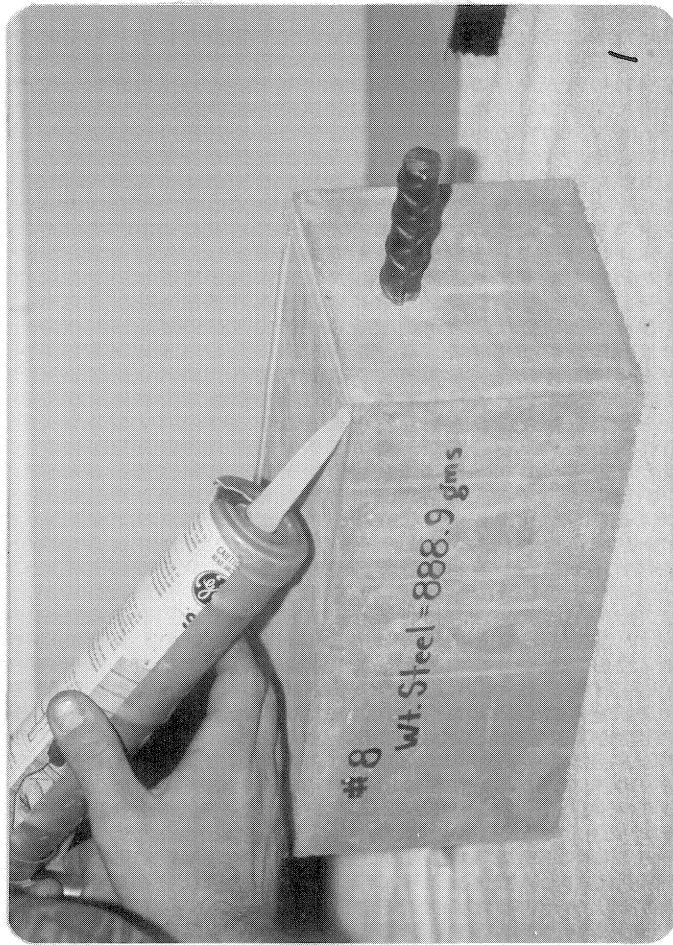
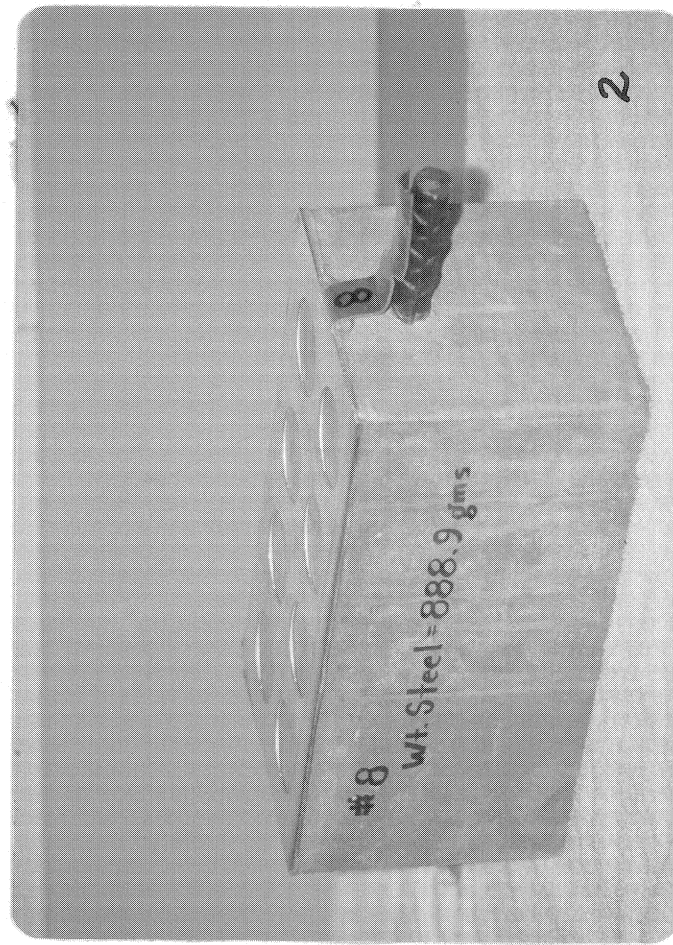
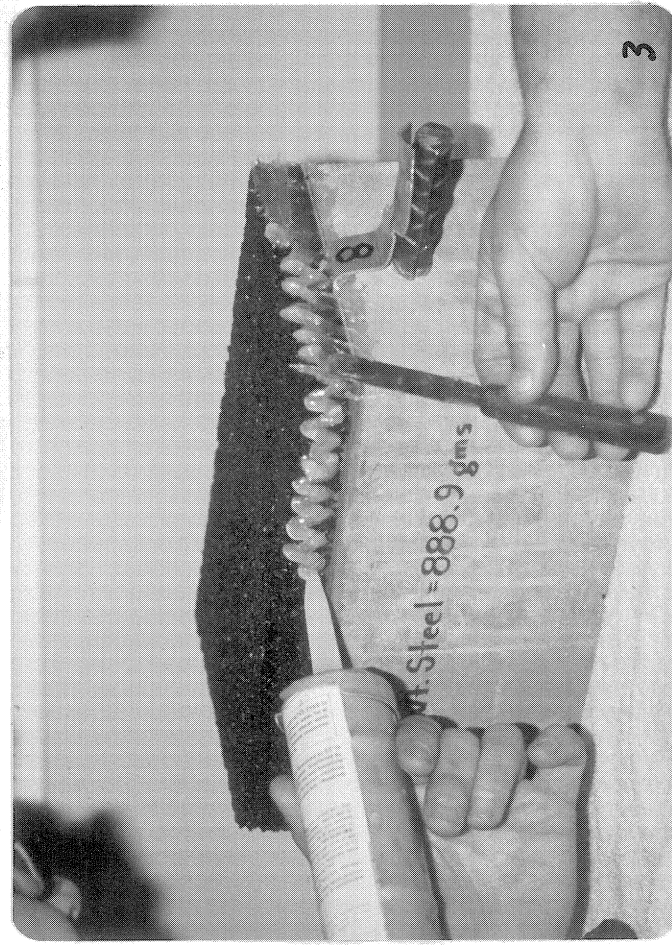
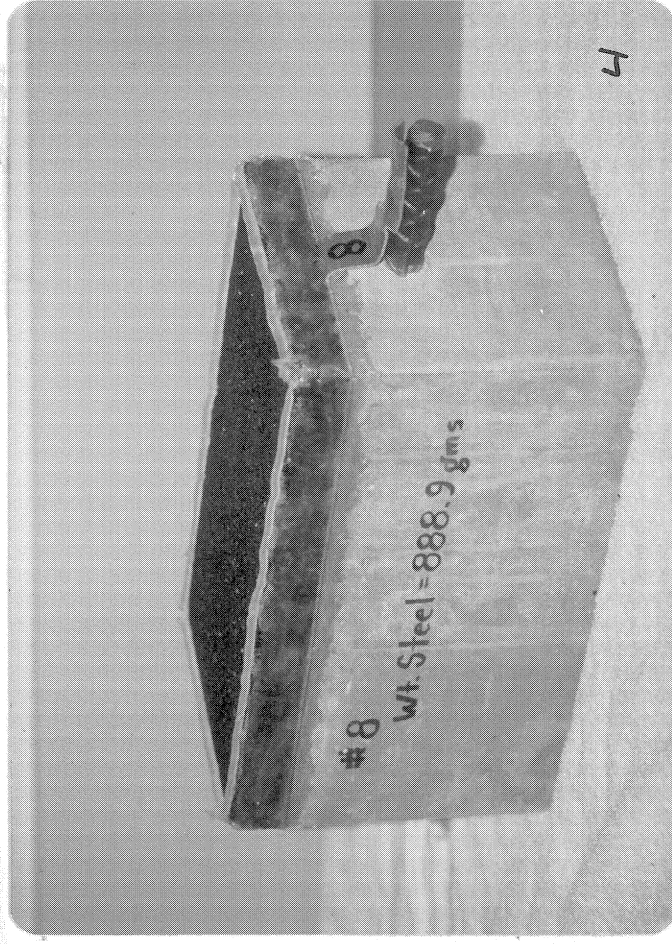
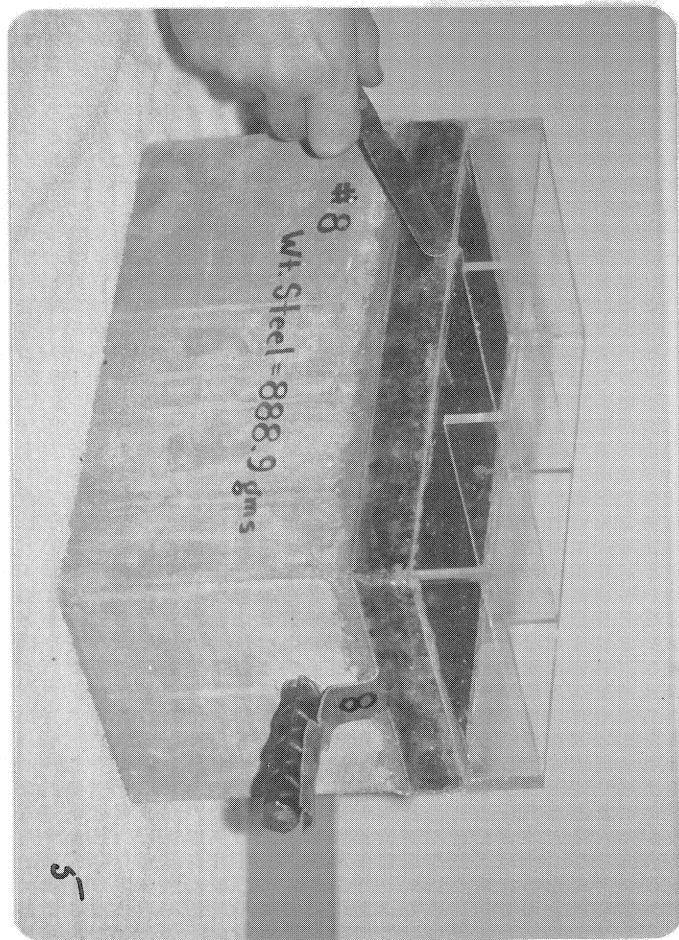
Pictures 1 through 5 - The method of preparation of the block and anode. Phase I.

Photos 1 through 5 illustrate a typical test block. The blocks were continuously exposed to the action of the salt solution at room temperature for the first seven weeks starting March 25, 1974. The salt solution was then removed and the blocks placed in a 115° oven for a week. Alternate cycles of one week wet and one week dry were then used during the rest of the investigation.

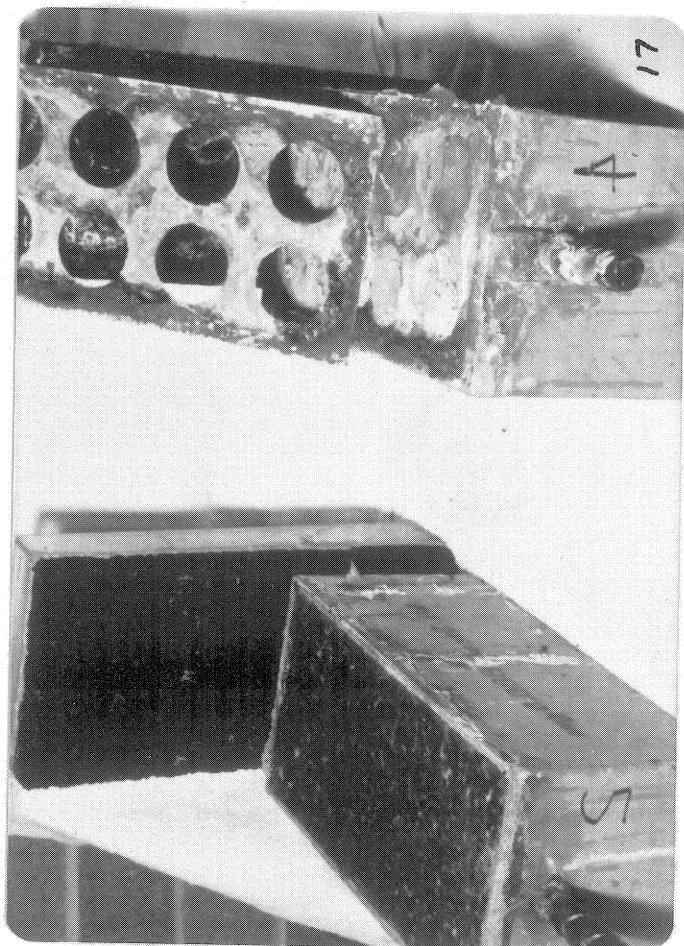
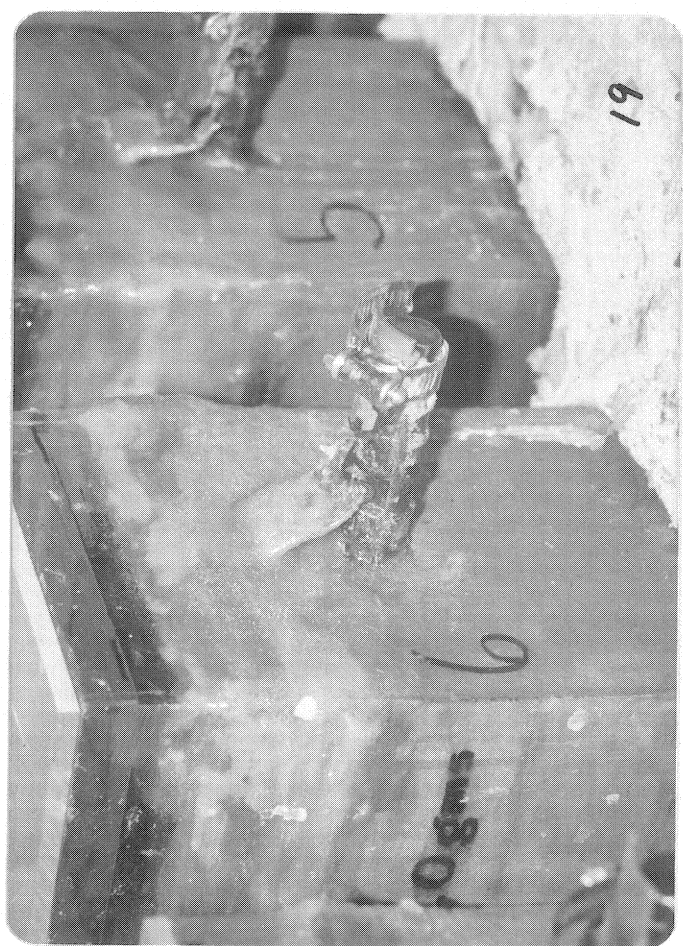
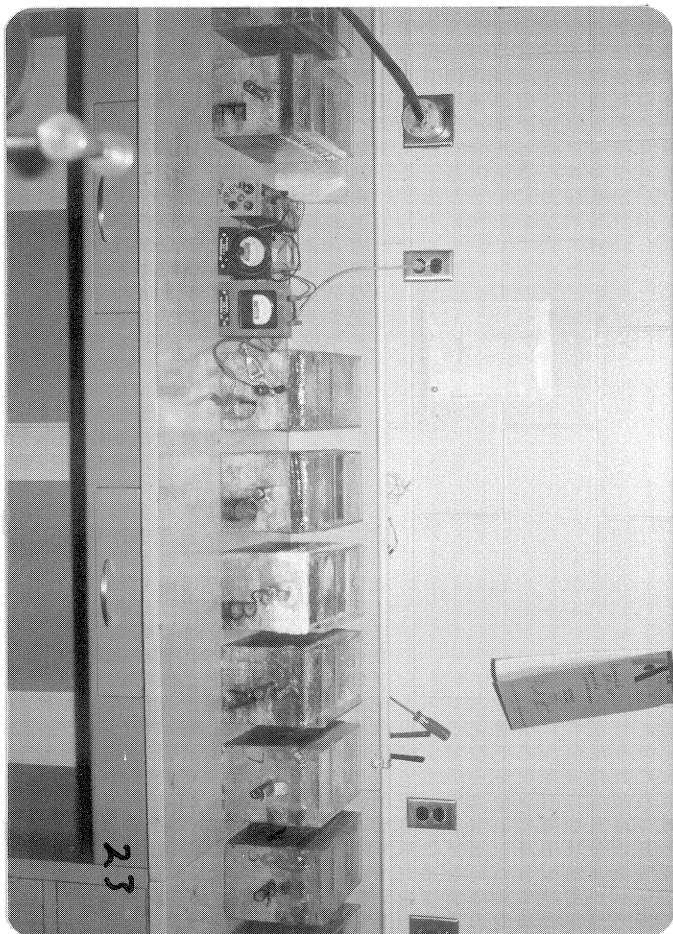
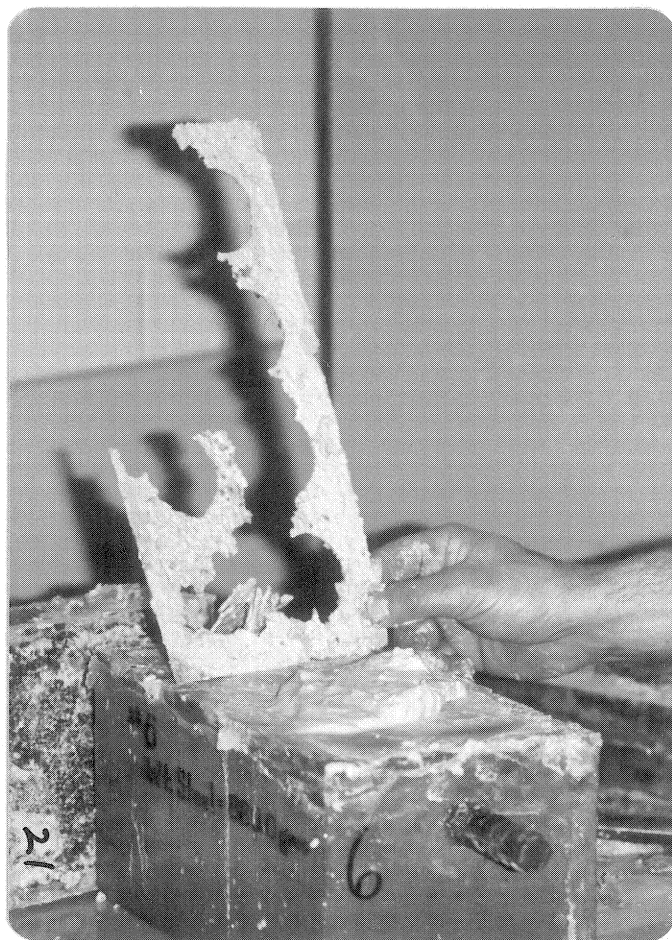
Pictures 19, 20 and 21 - Magnesium anode after testing in Block Number 6. Phase I.

Picture 22 - Magnesium anode after testing in Block Number 7. Phase I.

The magnesium anodes on the two concrete blocks were so deteriorated at the end of six weeks that testing was discontinued on the two specimens. (pictures 19, 20, 21, and 22) The volume of corrosion products formed by the magnesium anodes was of such magnitude as to appreciably raise the asphalt mat off the concrete block. The magnesium anodes themselves were so deteriorated that the weight of the uncoated metal remaining could not be determined. The steel reinforcing bars were removed from the two concrete blocks on November 20, 1974, six months after testing was discontinued, and the two rebars showed only minor corrosion loss (0.19% and 0.11% weight loss) which was probably
